**CWA COMPLIANCE EVALUATION INSPECTION REPORT
U.S. ENVIRONMENTAL PROTECTION AGENCY, REGION 5**

Purpose: Compliance Evaluation Inspection

Facility: Greenville Livestock, Inc
25815 Hugo Road
Centralia, IL 62801

Date of Inspection: September 9, 2010

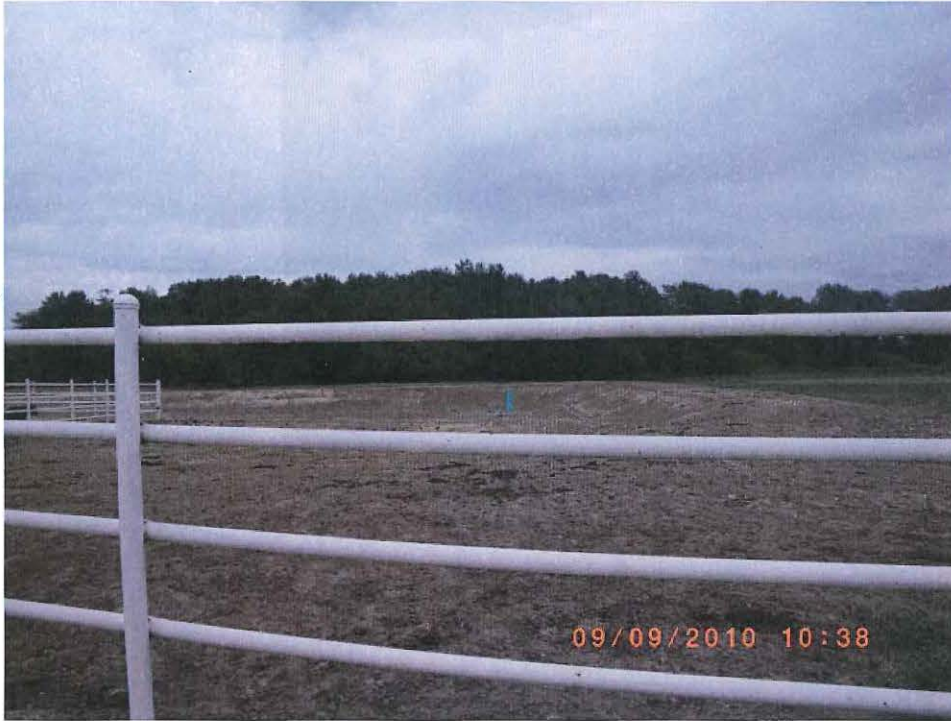
Location: Access road by Pen 14

IMGP0392: Riser Pipe for basin 1F by Pen 14. Process wastewater flows into the riser pipe in basin 1F and then flows by gravity to basin 1C by Pen 15. From there it is pumped to the Holding Pond.

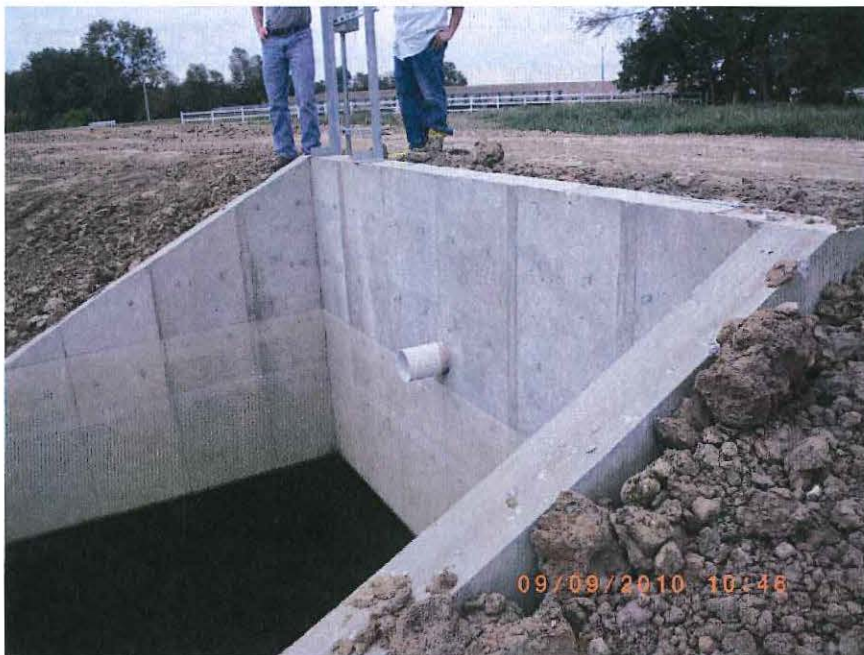
Location: Basin 1C.

IMGP0399: Pit for pump out of Basin 1C. Pipe in wall comes from Basin 1F by Pen 14.

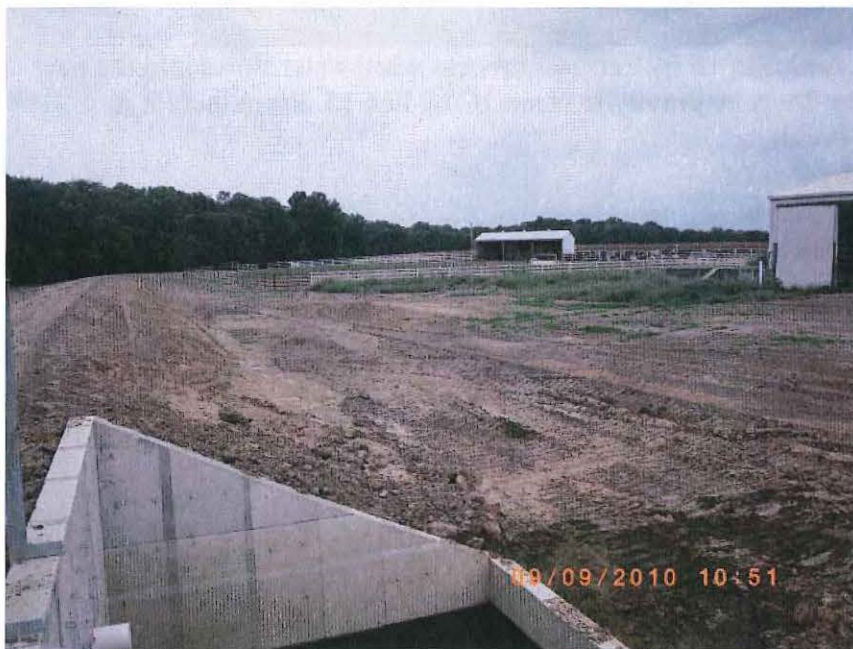
Location: Basin 1C.

IMGP0401: All the pens by Pen 15 are enclosed by a dirt berm, forming Basin 1C. All process wastewater would flow to the pit in Basin 1C and would then be pumped to the Holding Pond.

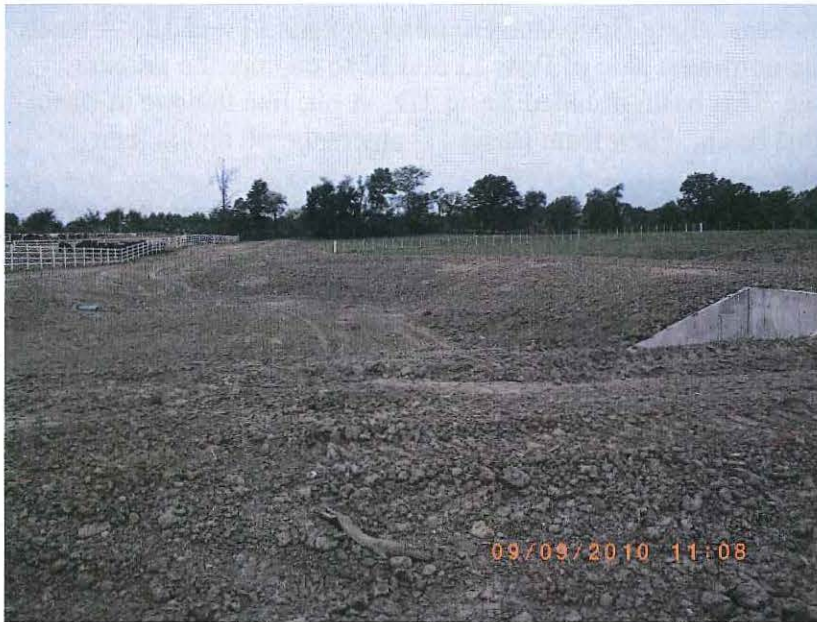
Location: Along Hugo Road northwest of Pens 11 and 12.

IMGP0411: Basin 1D by Pens 11 and 12 and concrete pit for pumping process wastewater from this basin to the Holding Pond. Pit also accepts flow from Basin 1E by Pen 10 and process wastewater from the Silage Area. All is then pumped to the Holding Pond.

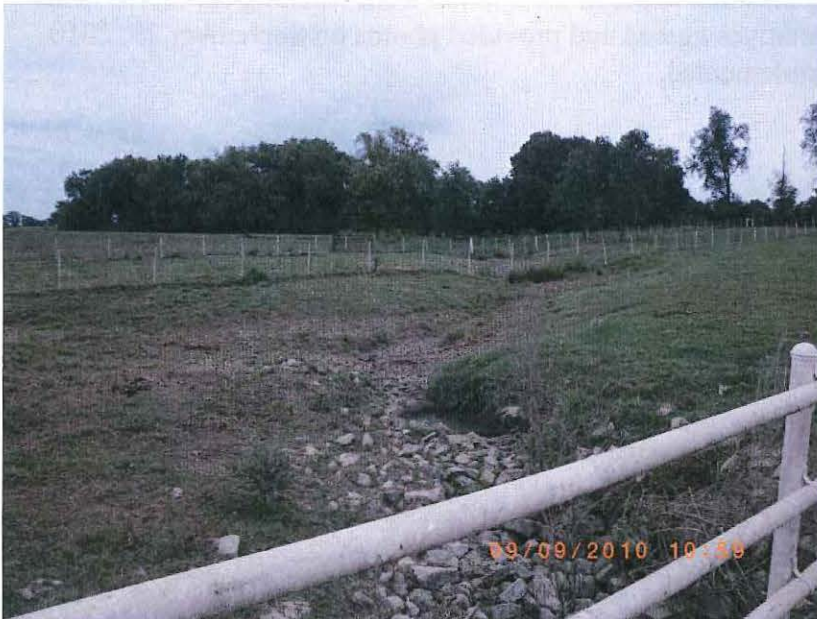
Location: Access road southeast of Pens 11 and 12.

In previous inspections, EPA identified a storm water pathway that flowed from the pasture of Pen 10, and through the feedlot of what was formerly known as the South Silo Area. The pathway then flowed through a culvert under an access road southeast of Pens 11 and 12, and exited in the pasture northwest of Pens 11 and 12. During this current inspection, EPA again observed that the storm water was able to mix with manure in the feedlot south of the South Silo Area and discharge to the yard northwest of Pens 11 and 12. A puddle in the storm water pathway appeared to contain manure from the feedlot. IEPA suggested changing the clean out pipe in the South Silo feedlot to a riser pipe to allow process wastewater from the South Silo Area to enter the pipe. IEPA also suggested a berm could be installed to block the manure from reaching the storm water pathway. Facility representatives agreed and provided photos on September 29, 2010 that this suggestion was implemented.

IMGP0404: Storm water pathway through pasture southeast of Pens 11 and 12. Storm water goes under access road via a culvert which discharges in the field beyond Basin 1D.

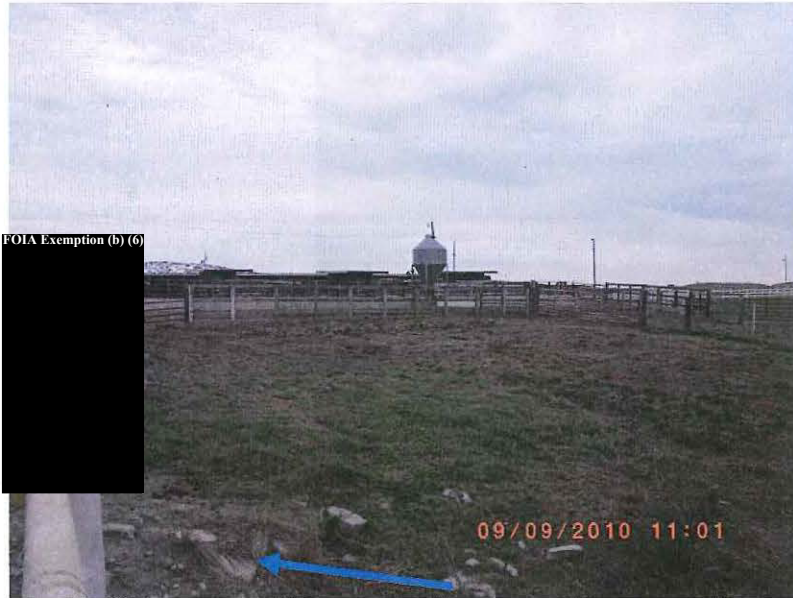
Location: Access road southeast of Pens 11 and 12.

IMGP0405: Area formally known as the South Silo Area. There is still a potential for process wastewater to enter storm water pathway which is located at the bottom of the photo. Storm water pathway is identified by a blue arrow.

EPA then drove back to the Greenville Livestock, Inc. office to brief [REDACTED] on the findings. EPA explained that while the basin system looks good around all the pens, the feedlot by the area formerly known as the South Silo Area still has the potential to allow process wastewater to enter a storm water pathway and discharge to Prairie Creek. EPA discussed the suggestions of the IEPA representatives.

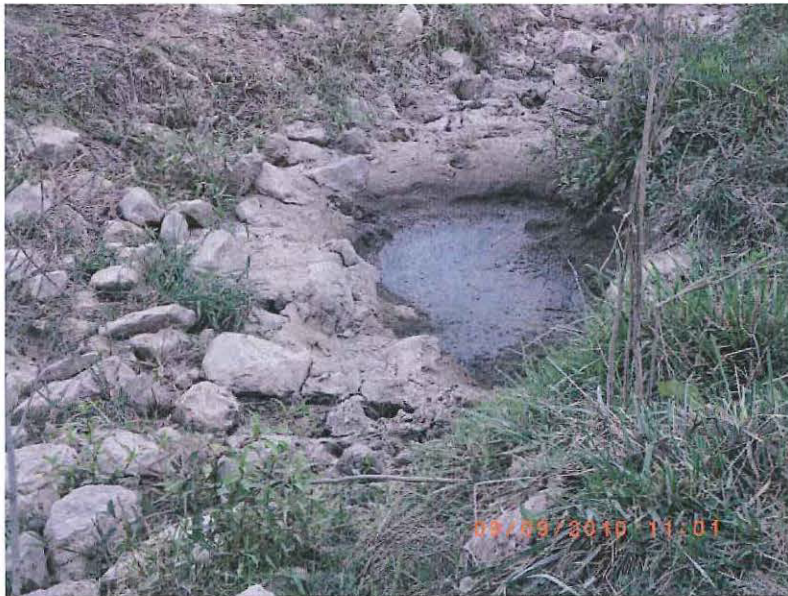
Location: Area formerly known as the South Silo Area.

IMGP0406: Standing puddle of water seems to contain manure and process wastewater. IEPA suggested berming up South Silo feedlot and changing a clean out pipe to a riser pipe. This would allow process wastewater from South Silo Area to tie in to the pipe that flows underneath.

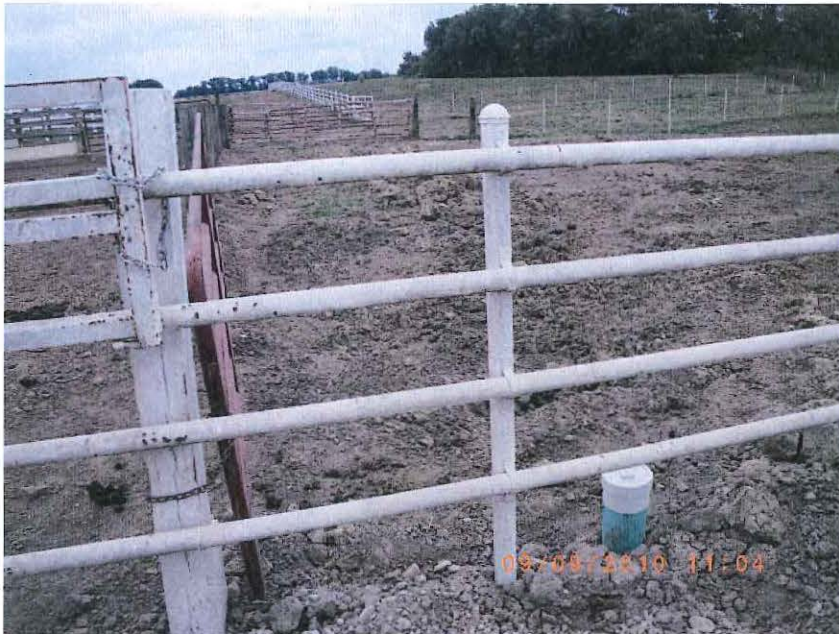
Location: South of South Silo Area.

IMGP0407: Cleanout pipe for process wastewater pipe from Pen 10 and Basin 1E. IEPA suggested adding a small basin around this pipe and then change it to a riser pipe to collect process wastewater from South Silo Area and berm around it to keep storm water pathway clean.

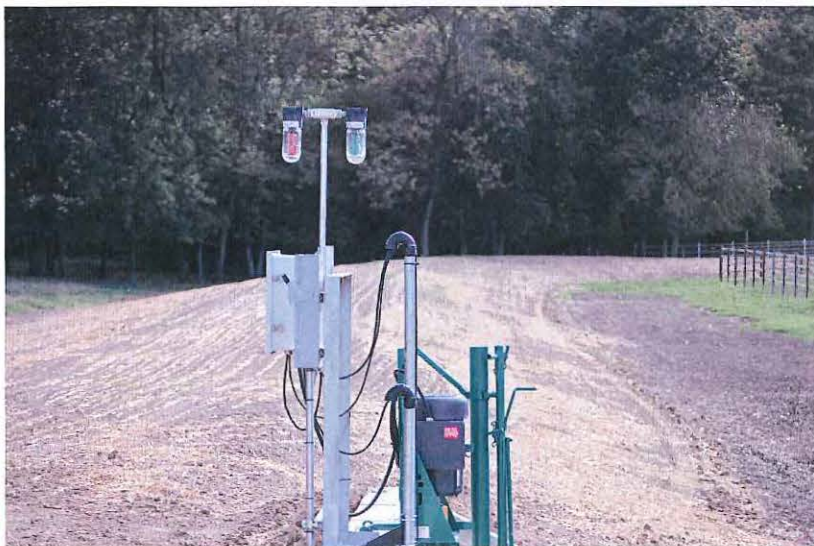
Location: Concrete pit in Basin 1C by Pen 15.

EPA and IEPA also noted that there was no backup system in place at the two pumps in the concrete pits to notify facility personnel that a pump had failed. IEPA suggested adding a light on top of the pump box to indicate that the pump wasn't working. Facility representatives agreed and provided photos on September 29, 2010 that this suggestion had been implemented.

dsc_0103: Photo provided by Greenville Livestock. Indicator lights have been installed at pump in concrete pit in Basin 1C.

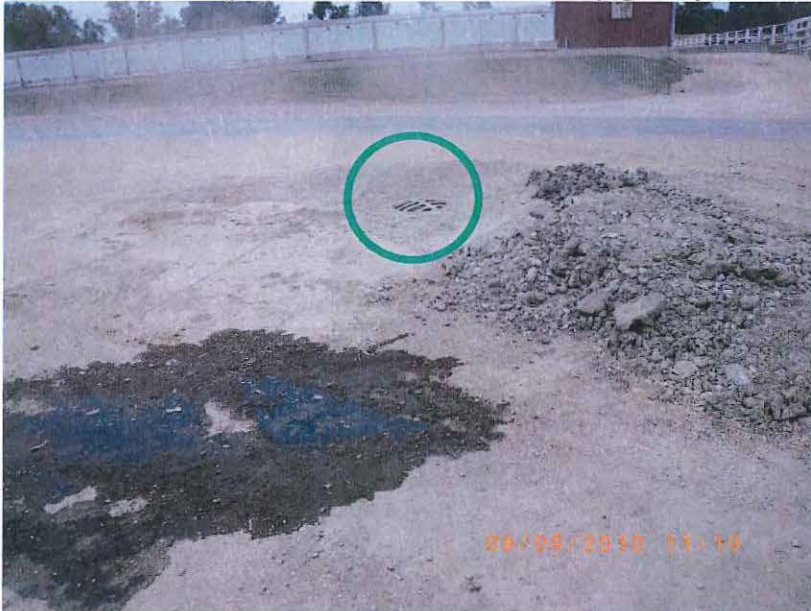
Location: Silage Area.

IMGP0420: Silage leachate flows into basin 1G via the drain. Drain identified by green circle.

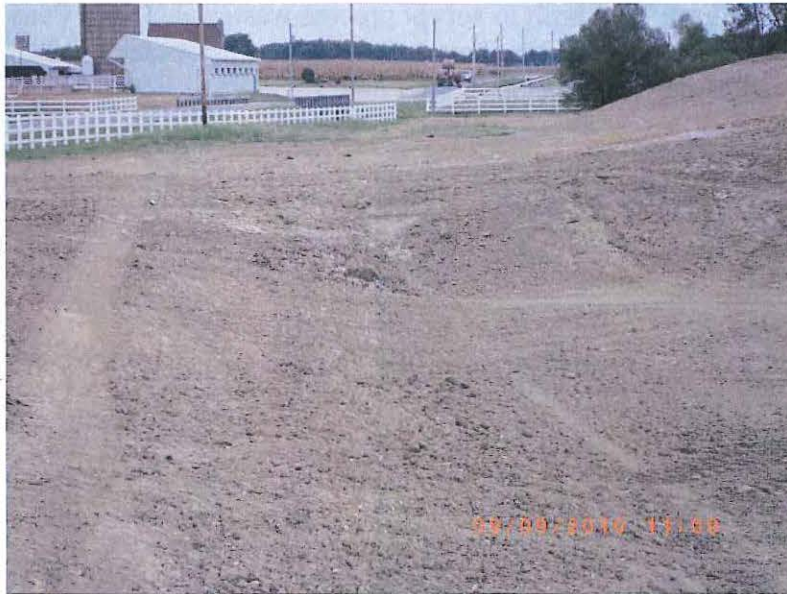
Location: Silage Area.

IMGP0416: Basin 1G collects process wastewater from silage area. It is then gravity fed under Hugo Road to a concrete pit in Basin 1D where it is then pumped to the Holding Pond.

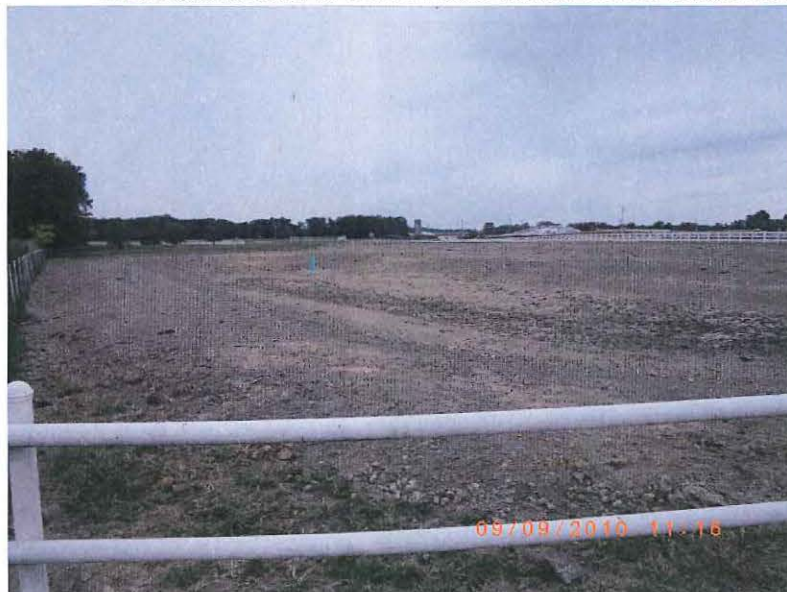
Location: Pen 10.

IMGP0421: Basin 1E for Pen 10. This is the beginning of the process wastewater pipe that goes under the South Silo Area feedlot and Pens 11 and 12. It discharges to the concrete pit in Basin 1D.

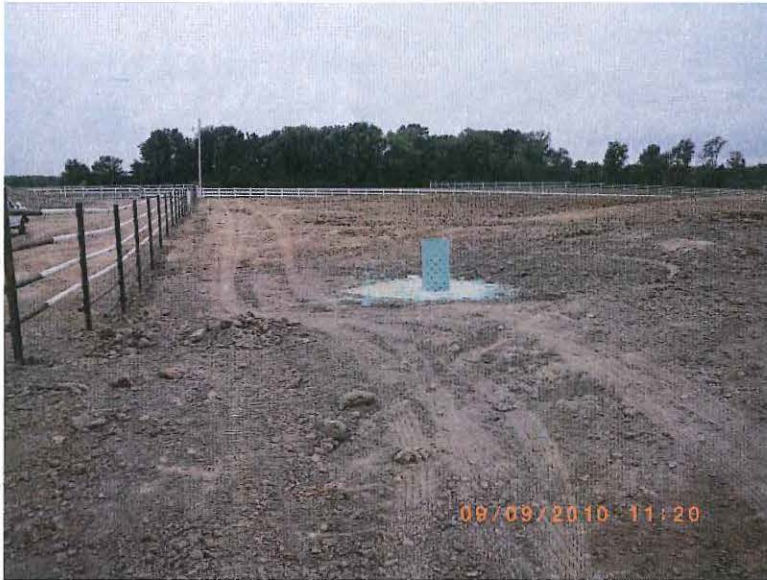
Location: Basin 1B.

IMGP0423: Riser pipe in this section of Basin 1B accepts process wastewater from Pens 1-3. Gravity takes flow to Holding Pond.

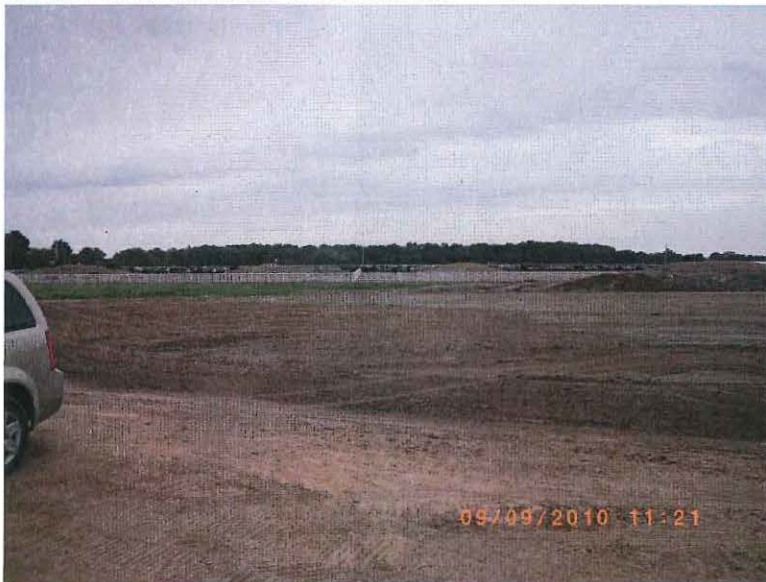
Location: Basin 1B.

IMGP0427: Another section of Basin 1B accepts process wastewater from Pens 4-8. The pipes from the two sections of Basin 1B "Y" together and flow by gravity to the Holding Pond.

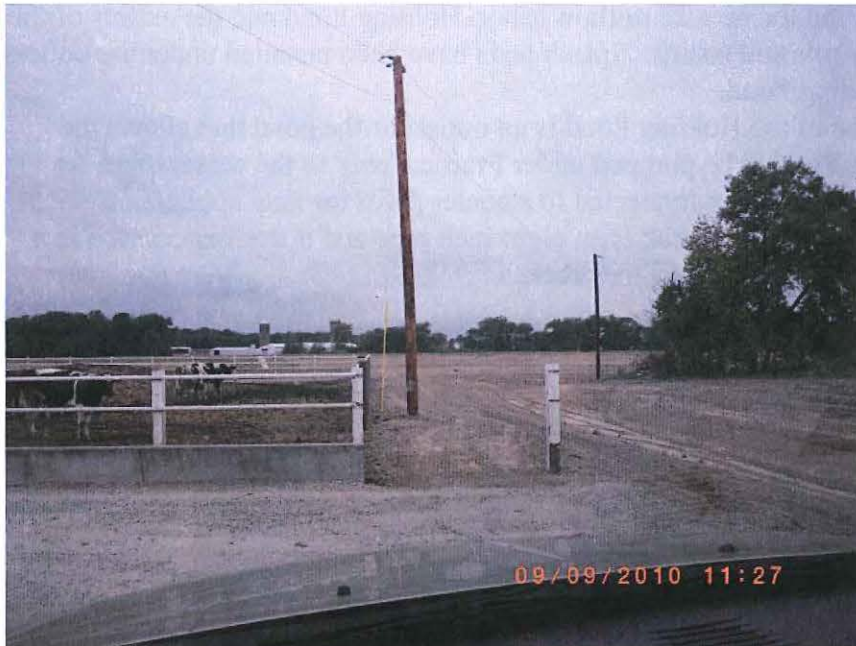
Location: Northeast corner of Pen 9.

IMGP0430: Process wastewater from Pen 9 flows to Basin 1A to the west of Pen 9. Basin 1A is in the background beyond the pen in the photo. From Basin 1A, the process wastewater flows by gravity to the Holding Pond.

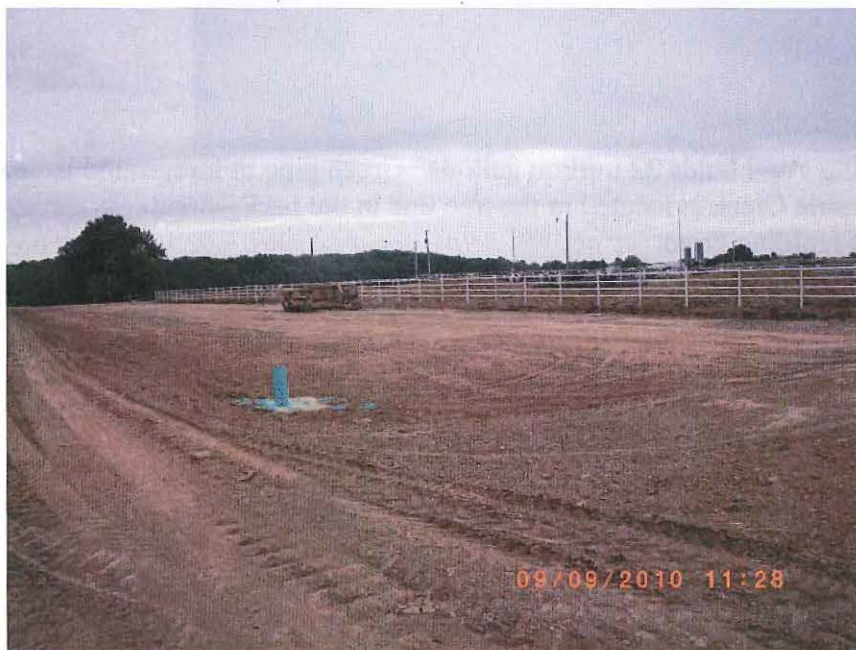
Location: West of Pen 9.

IMGP0431: Riser pipe in Basin 1A.

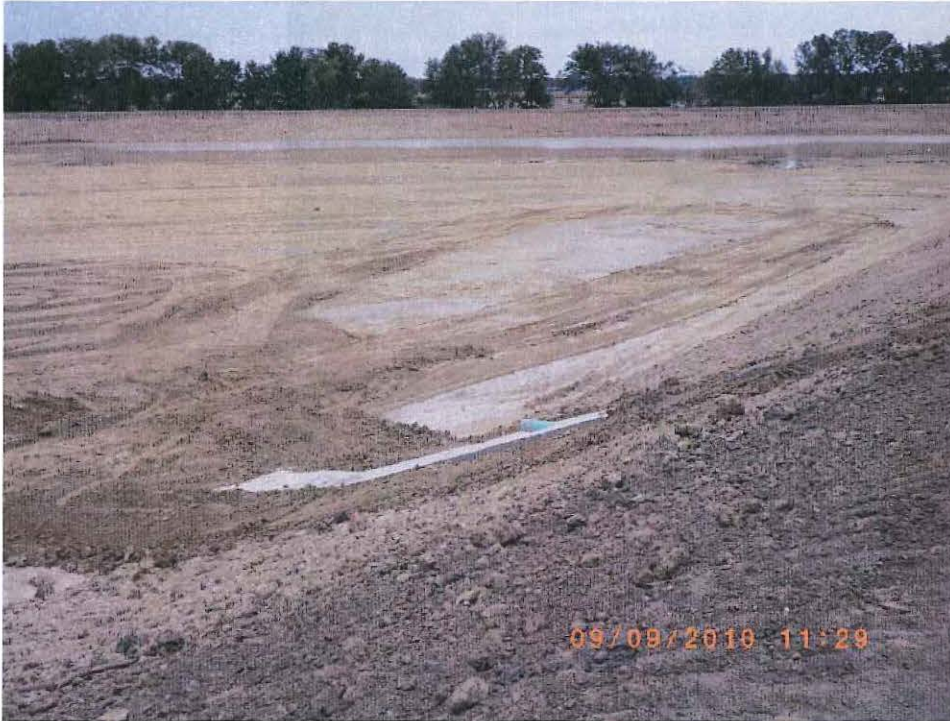
Location: East berm of Holding Pond.

IMGP0433: The Holding Pond holds 22 million gallons. Green pipe in foreground is pipe from basin 1A. Prairie Creek is located in the tree line in the background.

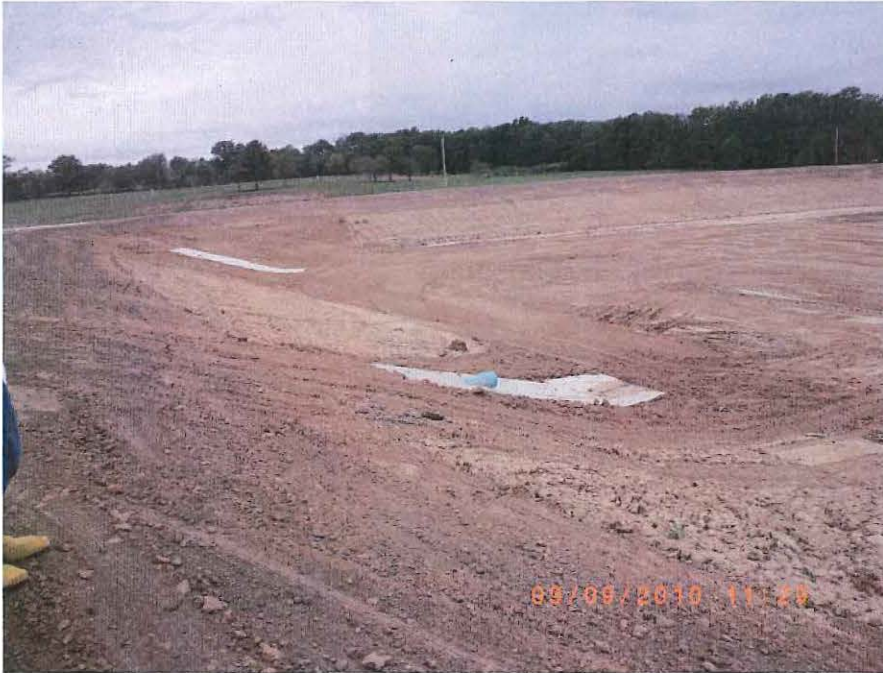
Location: East berm of Holding Pond.

IMGP0434: Pipe to Holding Pond from Basin 1B is in foreground. Further along the berm, the pipe from Basin 1D enters the Holding Pond.

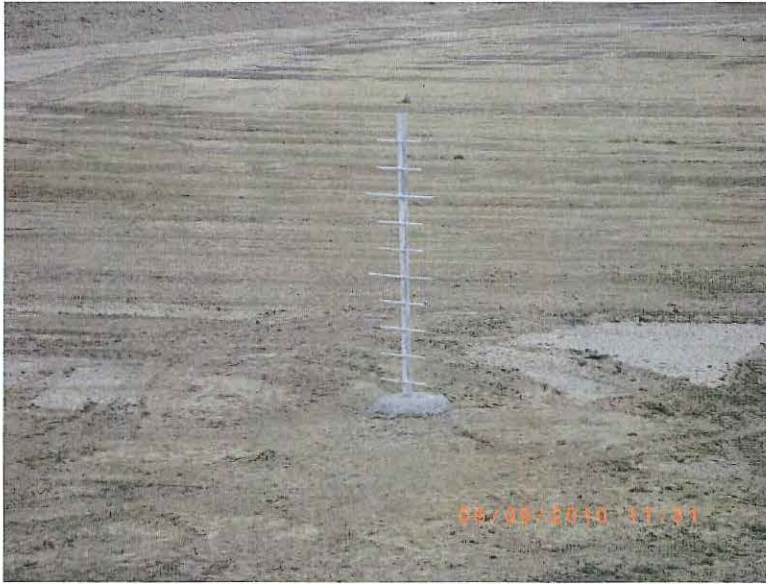
IMGP0439: Staff gauge in Holding Pond. Each rung is two feet of depth.
 Location: East berm of Holding Pond.
 Facing: West
 Date/Time: 09/09/10 11:31 A.M.

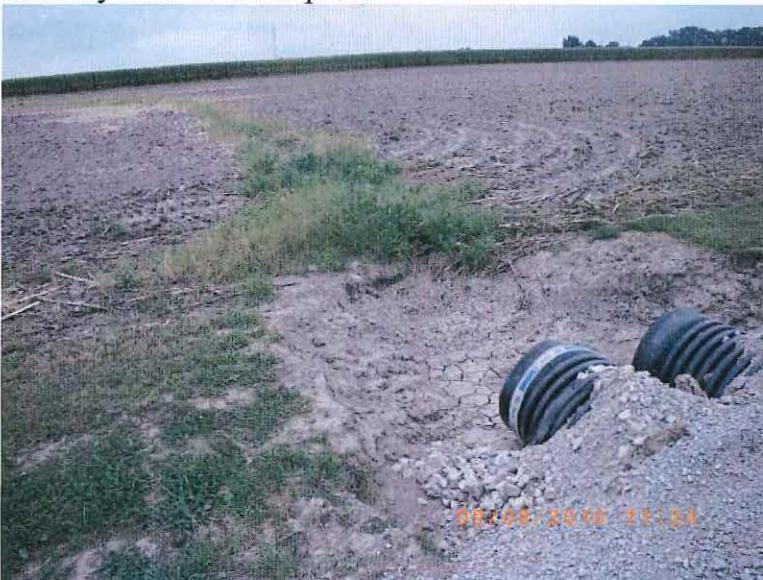
IMGP0429: Inflow from neighboring field is diverted from the Pens. It enters these pipes on the east side of the road east of Pen 4.
 Location: Access road on east side of facility.
 Facing: East
 Date/Time: 09/09/10 11:24 A.M.

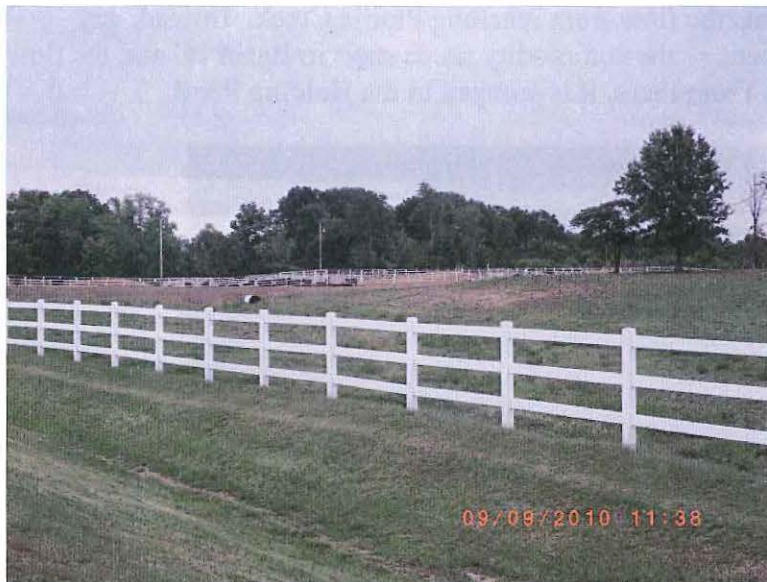
Location: Hugo Road northwest of Pens 11 and 12.

IMGP0440: The storm water culvert pipe outlet under Pens 11 and 12. Discharge is to the field beyond the pens and Basin 1D.

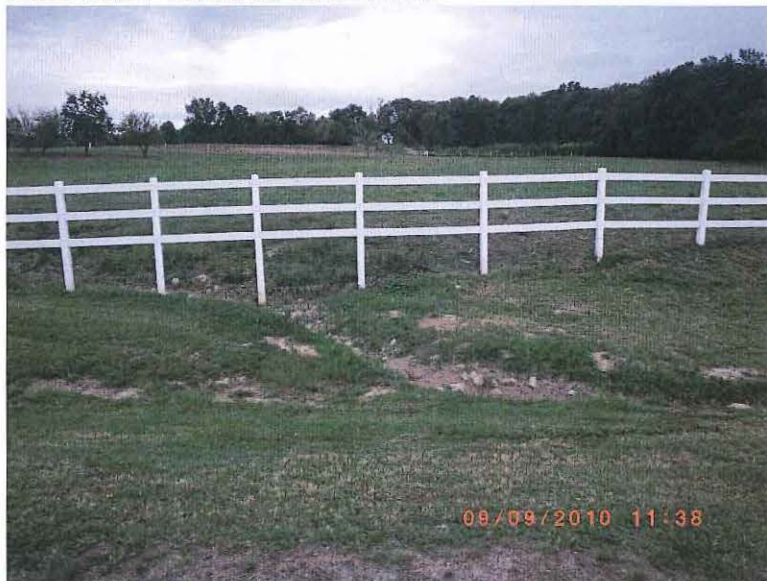
Location: Hugo Road northwest of Pens 11 and 12.

IMGP0442: Storm water pathway flows under fence and to roadside ditch on south side of Hugo Road before joining Prairie Creek.

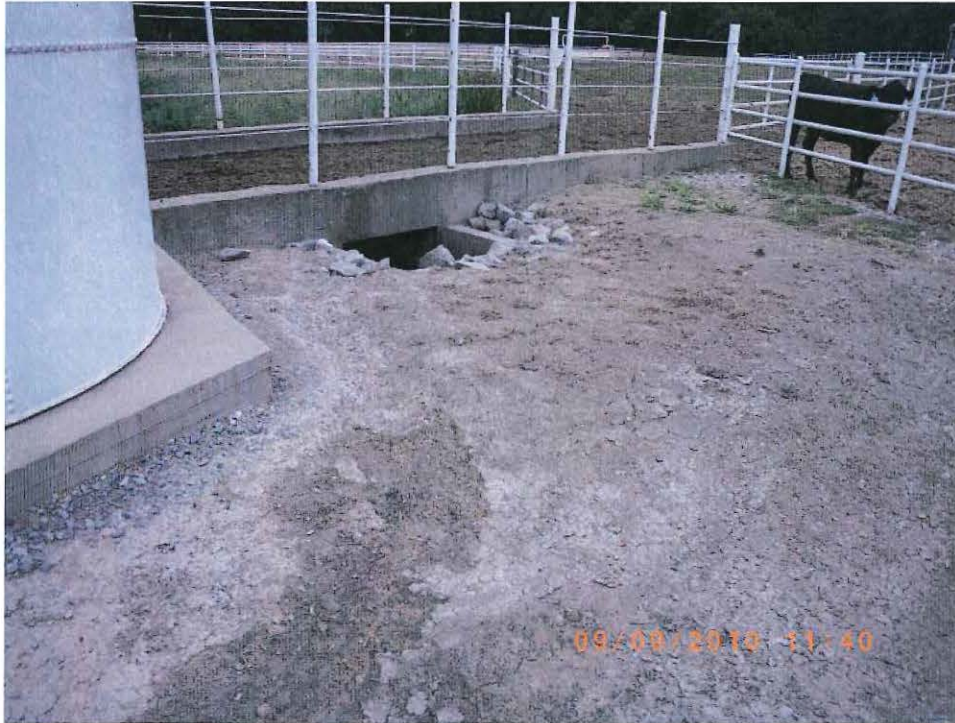
Location: Pen 15.

IMGP0444: Culvert for process wastewater near commodity barns and Pen 15. Flow goes to vegetated area behind fence. From there, the process wastewater would flow to basin 1C.

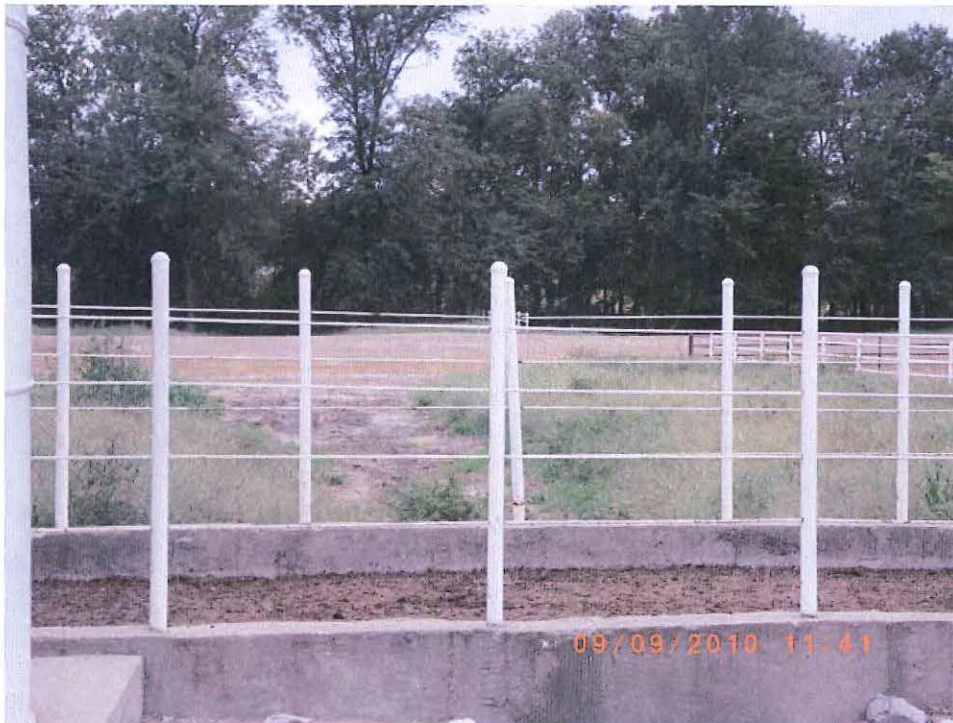
Location: Pen 15.

IMGP0447: Vegetated area that behind Pen 15. Berm for Basin 1C can be seen in the background.
